Westwood

City Facilities Assessment & Feasibility Analysis

Final Report

October 10, 2022

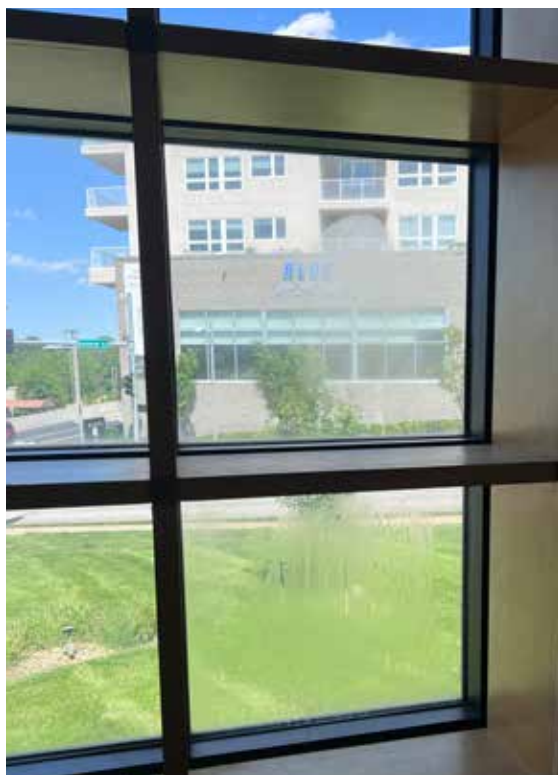
Failing glazing units

Glazing – The storefront glazing system has multiple IGU units with broken seals and therefore condensation is inside of the units. Facilities noted that quite a few units have already been replaced. Due to the small size of IGUs in the chamber room this means that there are a lot of chances for units to fail. The aluminum storefront system itself appears to be in decent shape but several snap caps have fallen off. Several sealant joints are dried and cracking at system perimeters.

Base Recommendations: All failing IGUs should be repaired; if repair is not possible units should be replaced. Replace all missing snap caps to match. All sealant joints should be scraped, cleaned and redone.

Expanded Recommendations: replace bay window assembly in Police Chief office. Replace all IGUs and snap caps

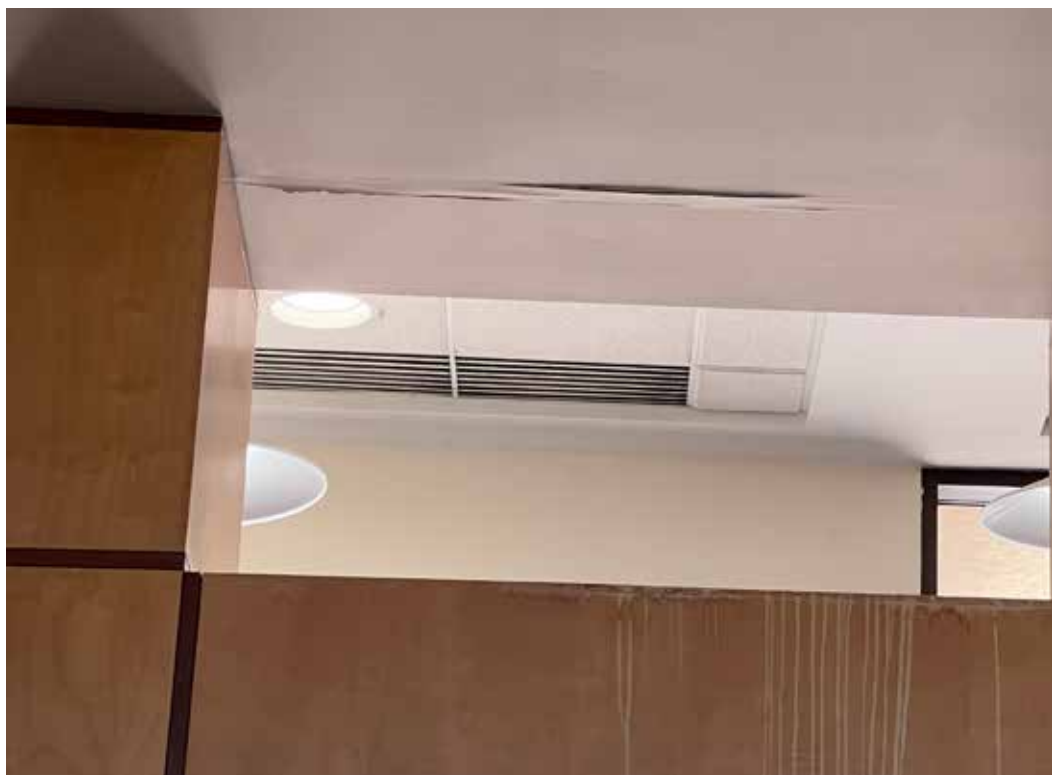
Interior ceiling and finish damage due to roof leak

Ceilings – Most lay-in ceilings are in overall average condition. Where leaks have occurred overhead, some tiles are stained and tiles near HVAC registers are dirty.

Recommendations: At a minimum all damaged and dirty tiles should be replaced. If a suitable match is not possible all ceiling tiles should be replaced to provide uniformity. All gypsum board ceilings should be repainted. See floor plans for detailed recommendations.

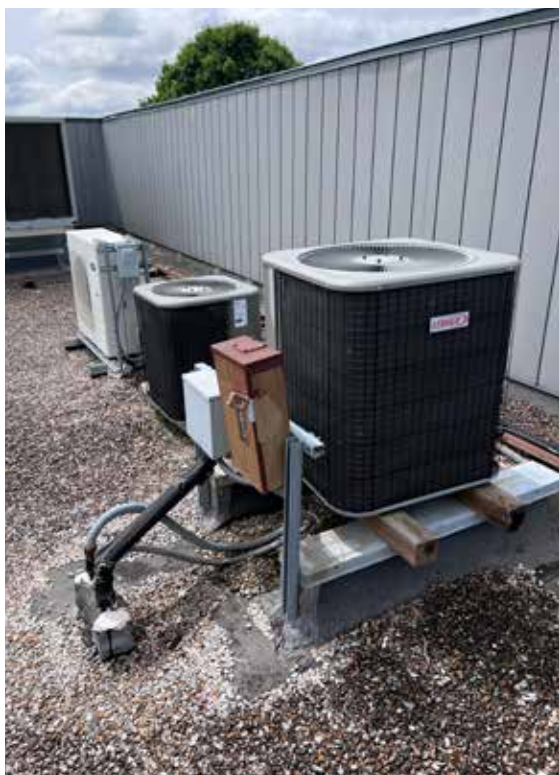
Mechanical units on original ballasted roof

Ballasted Flat Roofing – The original flat roof is a ballasted modified-bitumen roof. No leaks were observed, and facilities stated the only leaks they have noticed are when pitch pockets on the mechanical roof start to dry out and crack. When properly maintained these roofs have a typical life expectancy of 20 years or more.

Base Recommendations: The original roof is in average condition but will need replacement soon. It is recommended to do so along with other exterior repairs.

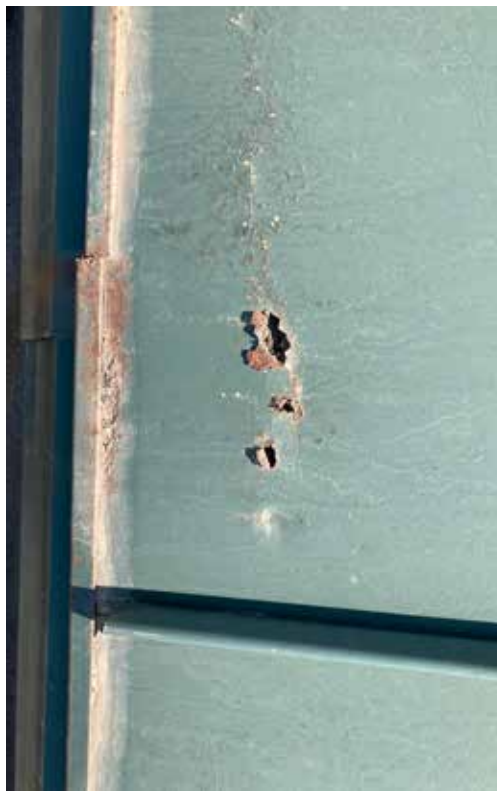
Rusting metal roof

Metal Roofing – Sloped roofs are made of standing seam metal. This is the original roof and had multiple seam battens that were coming off. Several scratches were noticed in the roofing material and they had started to rust. These roofs drain into a stainless-steel gutter system which had several clogs visible. Facilities noted that these gutters clog all the time and have been a constant source of leaks on the inside of the building. Both drain and overflow drain exit on to a ballasted flat roof.

Base Recommendations: Existing battens which are failing should be removed and replaced. Damaged roof panels should also be replaced. If they cannot be repaired, then the entire metal roof should be replaced. Alternate solution should be designed at stainless-steel gutter/overflow to prevent leaks.

Expanded Recommendations: Replace metal roof in its entirety.

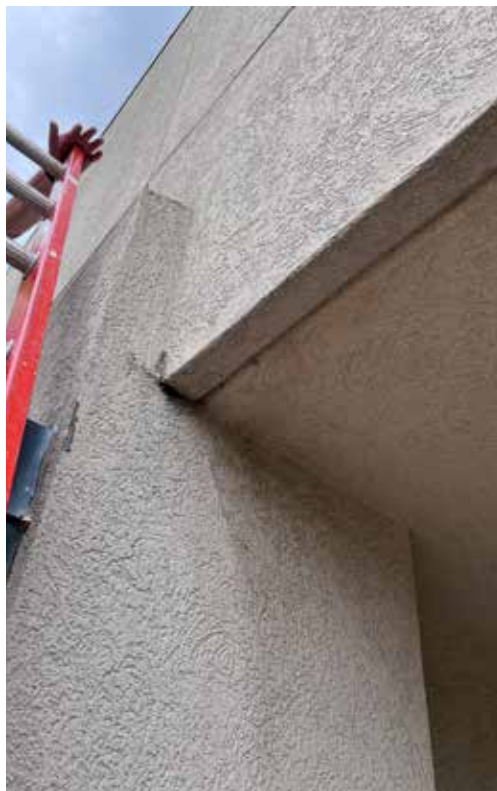
Damaged EIFS cladding

EIFS – The existing EIFS system has multiple locations where the outer finish layer is pitting and has eroded and the fiber backup scrim is visible. This is particularly noticeable at corners and control joints. The bottom of the finish system does have a metal flashing installed and it was noted as being wet during inspection. This is an indication that moisture has penetrated the EIFS outer layer but has reached the drainage plane, so the wall did appear to be draining properly. Most of the sealant joints at the perimeter of the EIFS were dry and cracked, which is a location for water intrusion.

Base Recommendations: All noticeable pitting and fiber exposure should be repaired back to original condition. If this is not possible then the finish system should be replaced. Care should be taken to ensure that wall continues to back vent and drain properly. All sealant joints should be scraped, cleaned and re-sealed. Any damaged flashing should be repaired/installed new.

Expanded Recommendations: Replace all EIFS cladding back to studs.

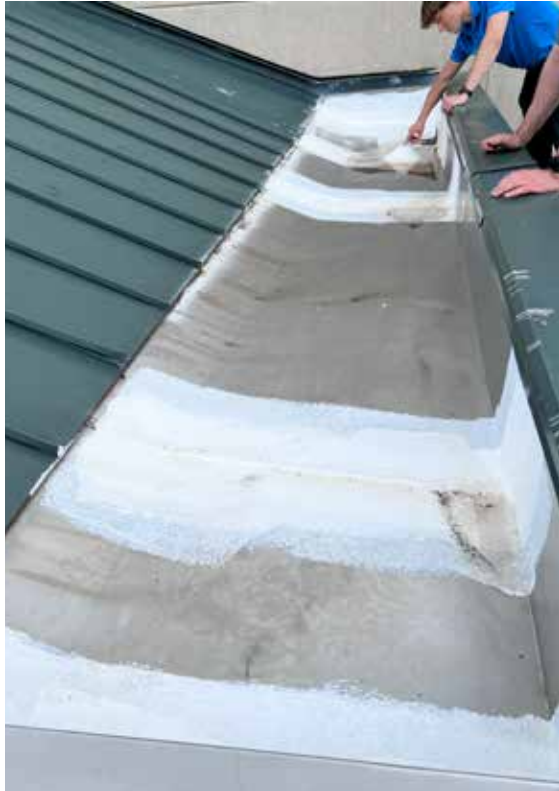
Leaking roof gutter

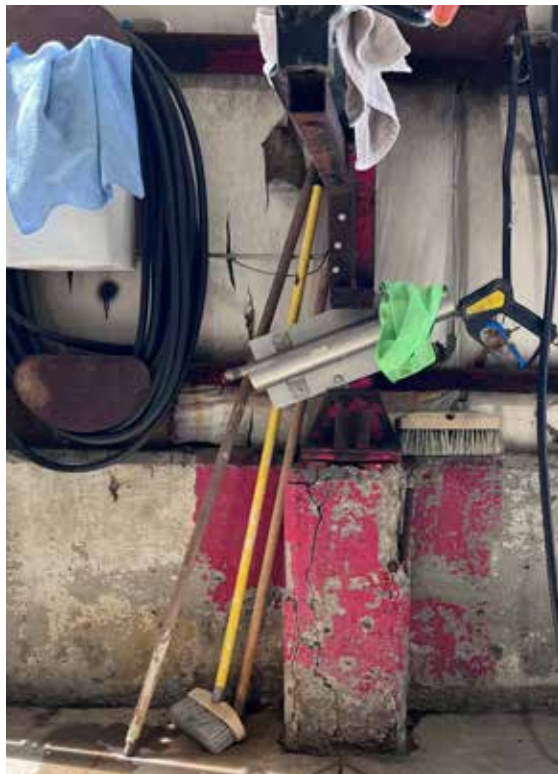
Damaged concrete column foundations

Foundations/Slabs – Existing foundations and slabs are made of concrete and foundation walls have several significant cracks, including at column base plates. Existing floor slabs have minor cracking.

Base Recommendations: Foundation cracks should be investigated by a structural engineer to ensure that building remains stable.

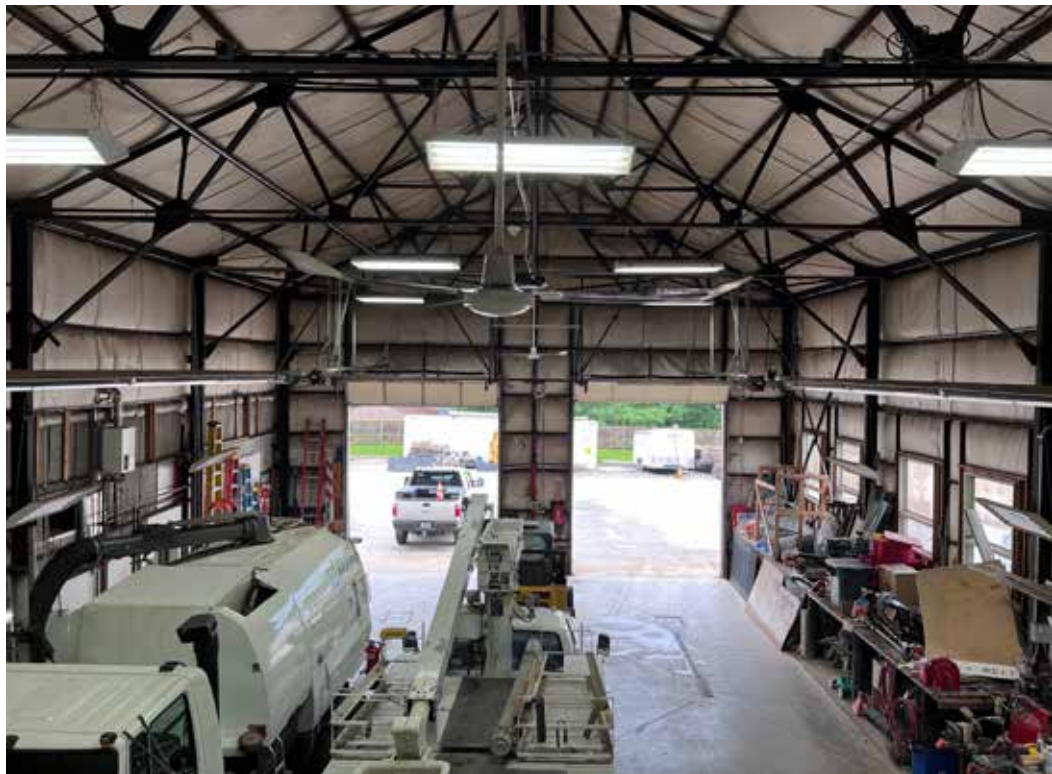
Truck bay without exhaust ventilation system

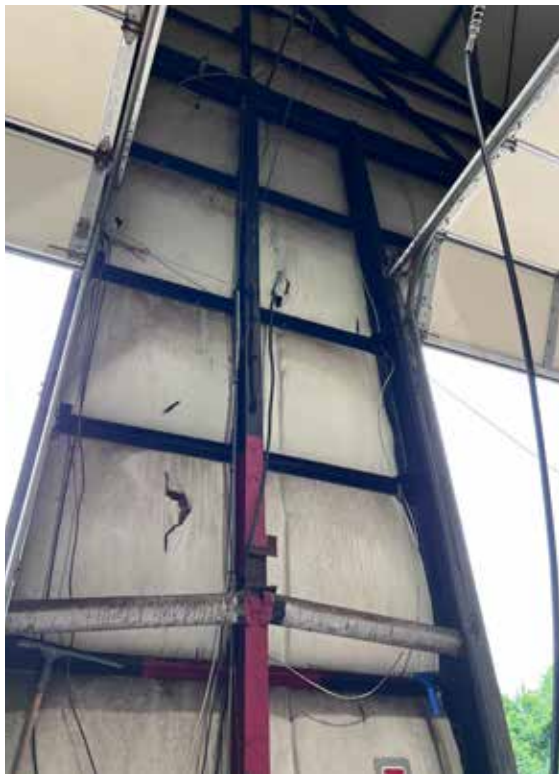
Damaged insulation on wall panels

Prefabricated Metal Panels – Multiple metal panels are damaged on the inside and therefore have questionable insulation values. There is some damage to exterior panels above high-bay garage door.

Base Recommendations: All damaged panels should be repaired at a minimum. If this is not possible, they should be replaced to match.

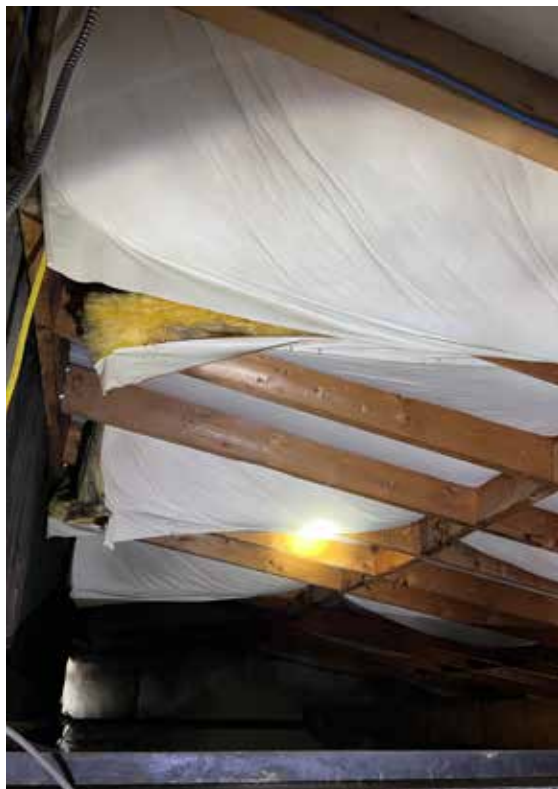
Crawl space on addition

Metal Building Structure – The existing metal building structure appears to be in good overall shape. Surface rust was noticed on several members. The one-story addition to the east was framed with wood joists and is supported by lag screws to wood members spaced between metal building girts. Several screws missed members and spacing is very uneven with significant cuts and notches out of wood members.

Base Recommendations: Metal building structure should be scraped and repainted, with all surface rust removed. The structure for the addition is highly questionable at best and does not meet code. It should be evaluated by a structural engineer and repaired or replaced to meet code.

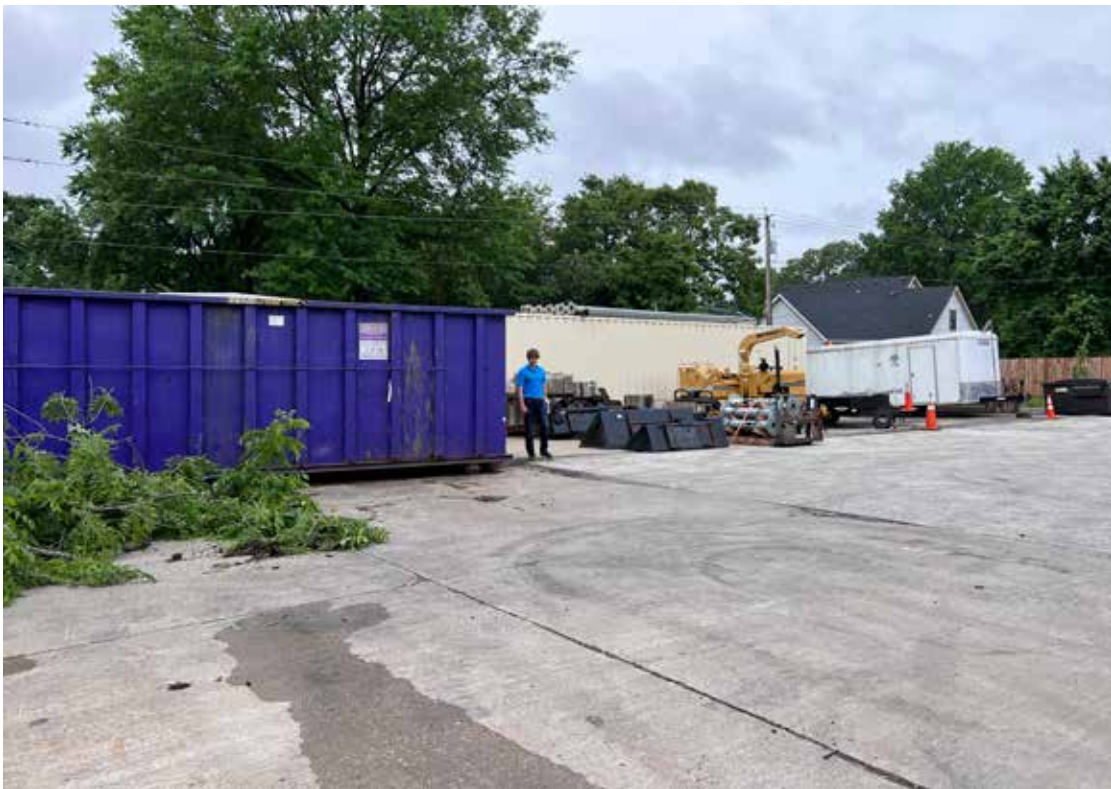
Storage units in yard due to lack of space
